INSPECTION REPORT: KENSINGTON GOLD MINE

Date of Inspection: Tuesday February 19, 2019
Date of Report: Tuesday March 5, 2019
USDA Forest Service Inspector: Richard Dudek

This inspection included the Access roads, Comet Development Pile, Comet Water Treatment Plant (CTWP), Sherman Creek Outfall, Kensington mill area, Pit 4, the TTF area, and the fuel depot.

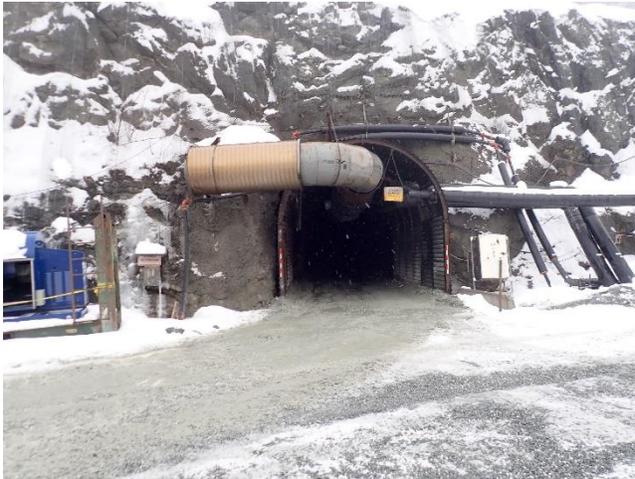
Photo 1. Jualin adit.

- **This spring Coeur Alaska plans to construct a ramp from the Jualin adit (Photo 1) to the mill.**

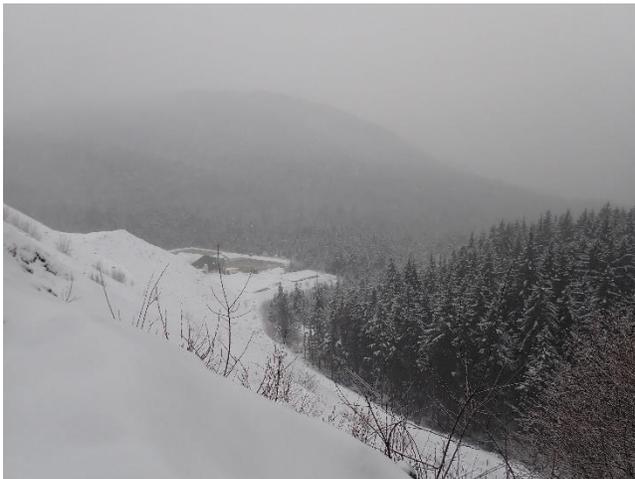
Photo 2. Comet development pile.

Currently, no waste rock is being deposited at this location (Photos 2).

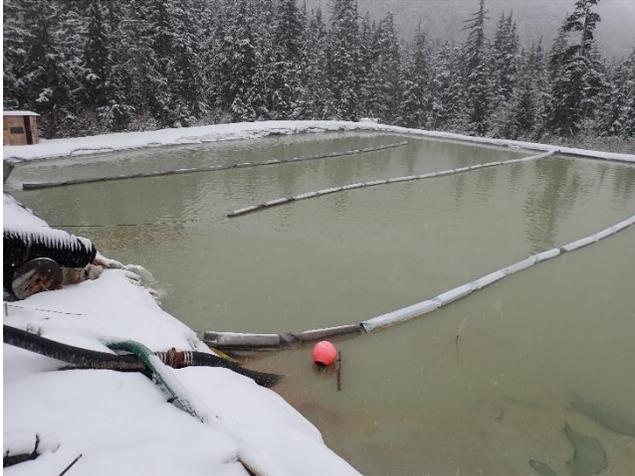
Photo 3. Pond-1.

On 2/19/2019, the CWTP was treating 1500 gallons per minute (gpm). Pond-1 (Photo 3) was receiving mine site water, and Coeur Alaska personnel recently re-installed silt curtains in the pond. Pond-2 (Photo 4) was receiving some overflow water from Pond-1, and backwash from the CWTP.

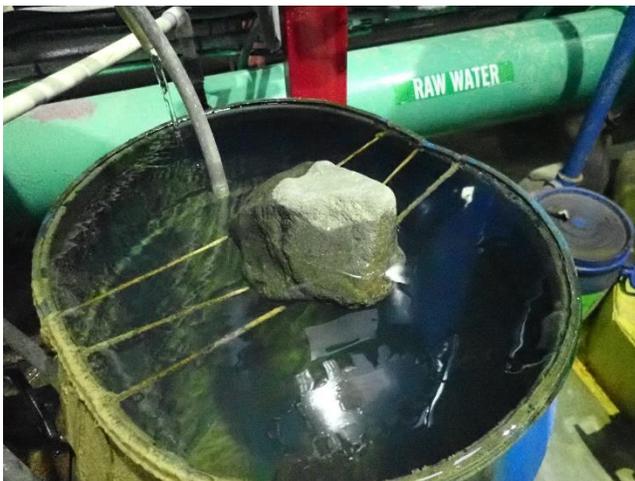
White material was not observed on the test rock used for monitoring the precipitation of white material from treated mine site water (Photo 5).

Photo 5. The test rock used for monitoring the precipitation of white material.

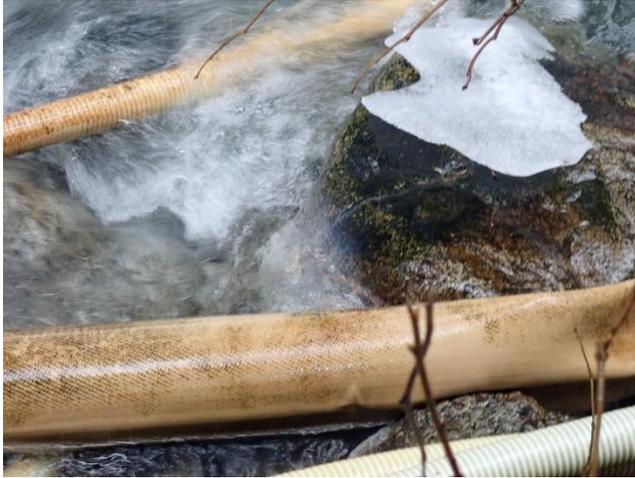
White material was observed in Sherman Creek Outfall 001 (Photo 6).

Photo 6. White material observed in the creek bed.

- Inspect the access roads.
- Inspect the Comet water treatment plant and settling ponds.
- Inspect for white material in Sherman Creek.
- Inspect the TTF area.

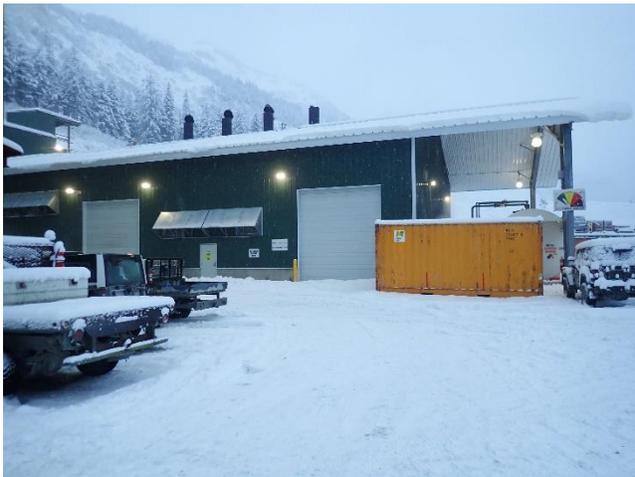
The new 4.0-megawatt generators (Photo 7) are online and supplying power to the mine site. This summer, Coeur Alaska plans to remove the old generators from site (Photo 8).

Photo 7. The new powerhouse station with four 4.0 MW generators.

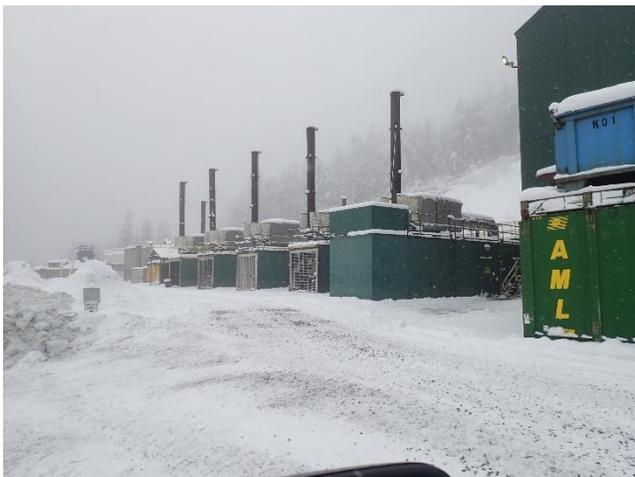
Photo 8. The old decommissioned generators.

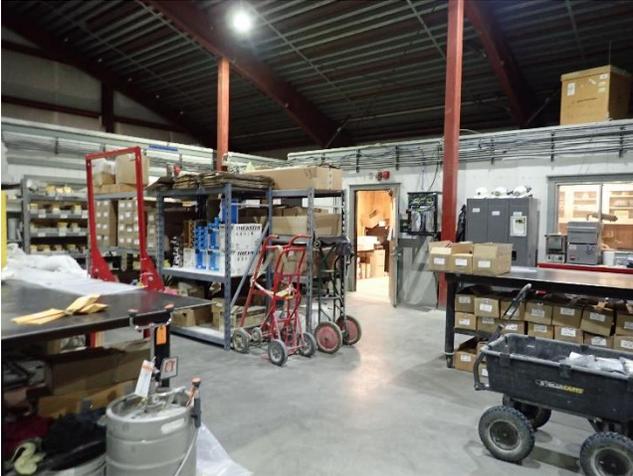
Photo 9. The assay laboratory.

Good housekeeping practices were observed inside the assay laboratory (Photo 9) (Appendix 4g BMP Plan; Table 4-1).

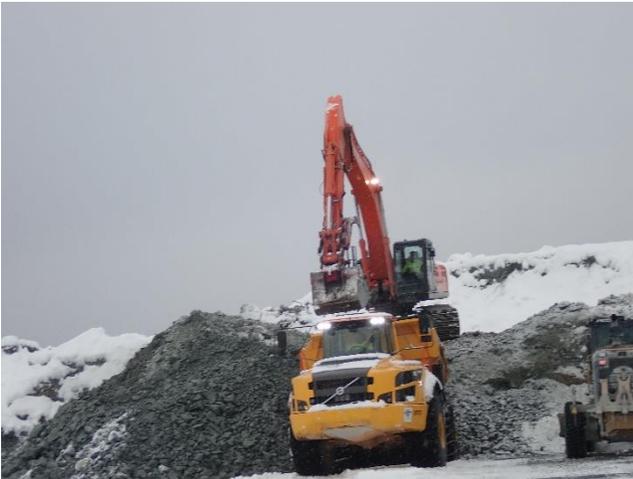
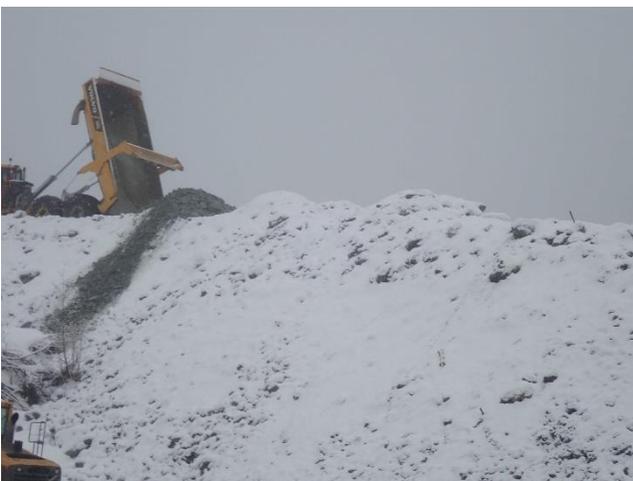
Waste rock from the Kensington development pile is being relocated to this location (Photos 10-11). The purpose for this was to help reduce the high volume of traffic around the mill area when a contractor is on site removing waste rock.

Photo 10. The Kensington Development Pile.

Photo 11. Waste rock from the Kensington development pile is being deposited at Pit 4.

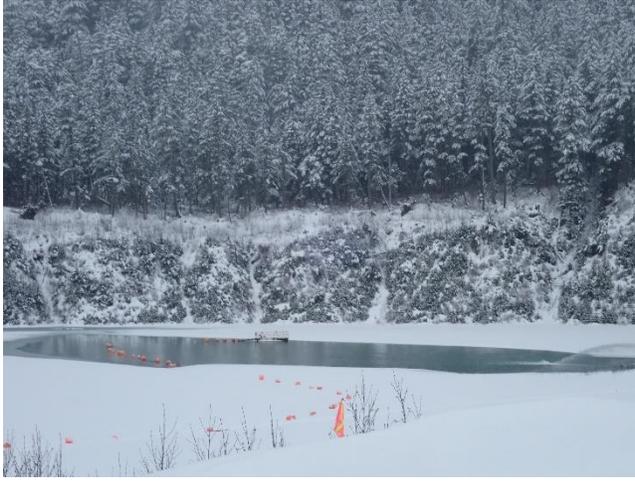
The tailings barge is now depositing in the north-west area of the TTF (Photo 12).

Photo 12. The TTF tailings deposit barge is now located in the NW TTF area.

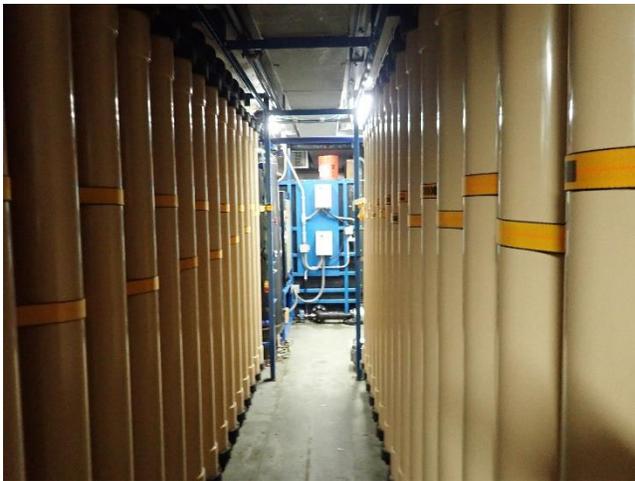
Photo 13. The microfiltration system.

The TTF water treatment plant's net treatment was 1400-gpm. To help prevent clogging of the reverse osmosis (RO) filters from silts and algae, Coeur Alaska began using a micro-filtration system (Photo 13) as a pre-filter prior to the RO treatment (Photo 14). The micro-filter is able to filter influent water at rates of 600-800 gpm. At the time of the inspection, the micro-filtration system and the RO system were both treating 600-gpm. The water withdrawal rate from upper Slate Lake was 240 gpm. At the time of the inspection, the water treatment plant was tidy and in order (Photos 15).

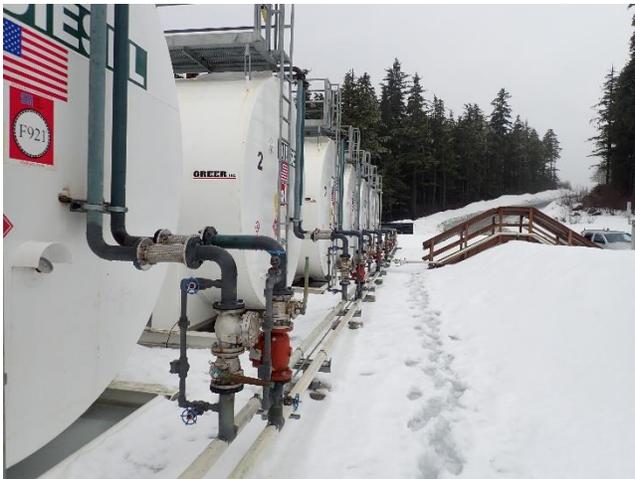
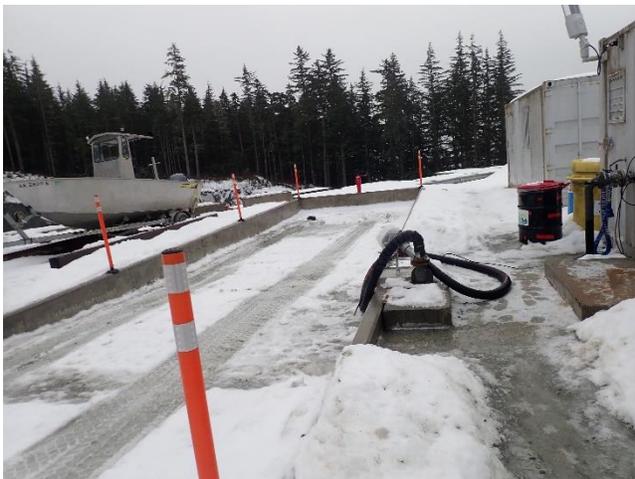
The fuel depot was tidy and in order (Photos 16-17). No fuel spills or leaks observed in the fuel depot and on the refueling pad.

Photo 16. Coeur Alaska's fuel depot.

Photo 17. The refueling pad at the fuel depot.
